Report No. 1312-02-B-6R2

Geotechnical Review of Preliminary Tentative Map and Grading Plan, Otay Ranch Subject:

Village 14 and Planning Areas 16/19, County of San Diego, California

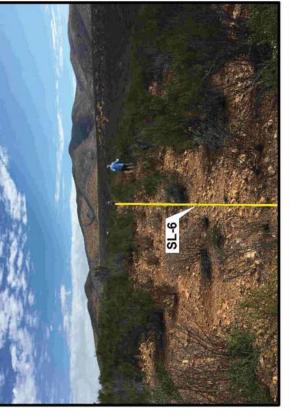
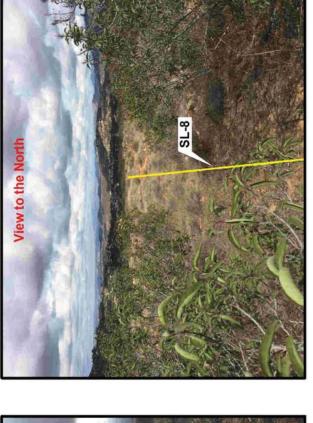
SITE PHOTOGRAPHS (SL-5 through SL-8)

The project site is generally located along the south side of Proctor Valley Road in or near the Jamul area of San Diego County, California (Figure 1). The study areas included several slopes and ridges in the project area. Several dirt roads and trails cross portions of the site. Vegetation in the area consists of annual grass, brush, and scattered small trees. Numerous outcrops of crystal-line rock were observed on and near the property. Figures 2a through 2g and 3a through 3c depict the site conditions in the area of the seismic traverses.

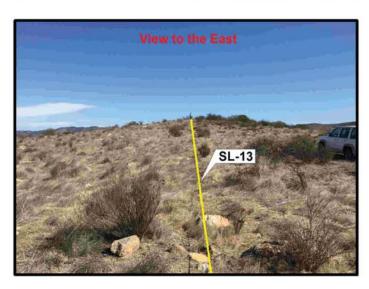
SITE PHOTOGRAPHS (SL-9 through SL-13) Proctor Valley Road Jamul, California

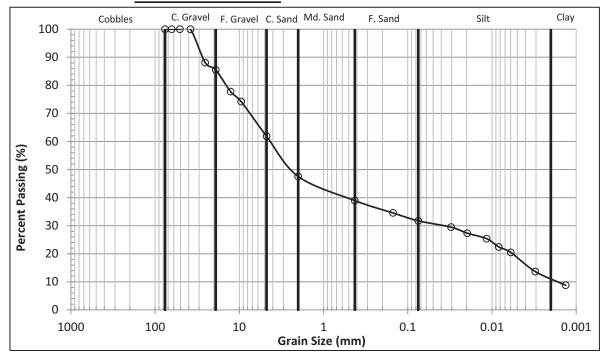
Depth: 18-19 '
By: HM

Grain Size	Grain Size	Amount
(in/#)	(mm)	Passing (%)
3 "	76.20	100.00
2 1/2 "	63.50	100.00
2 "	50.80	100.00
1 1/2 "	38.10	100.00
1 "	25.40	88.07
3/4 "	19.05	85.52
1/2 "	12.70	77.76
3/8 "	9.53	74.24
# 4	4.75	61.86
# 10	2.00	47.54
# 20	0.85	#N/A
# 30	0.60	#N/A
# 40	0.425	38.93
# 50	0.30	#N/A
# 60	0.212	#N/A
# 100	0.15	34.54
# 200	0.075	31.74
Hydro	0.0306	29.48
Hydro	0.0197	27.33
Hydro	0.0116	25.38
Hydro	0.0083	22.45
Hydro	0.0060	20.50
Hydro	0.0031	13.66
Hydro	0.0013	8.78

Summary		
% Gravel =	38.1	
% Sand =	30.1	
% Fines =	31.7	
Sum =	100.0
